WYMAN POND DAM

MA 00641

**PHASE I INSPECTION REPORT
NATIONAL DAM INSPECTION PROGRAM**

AUGUST 1978

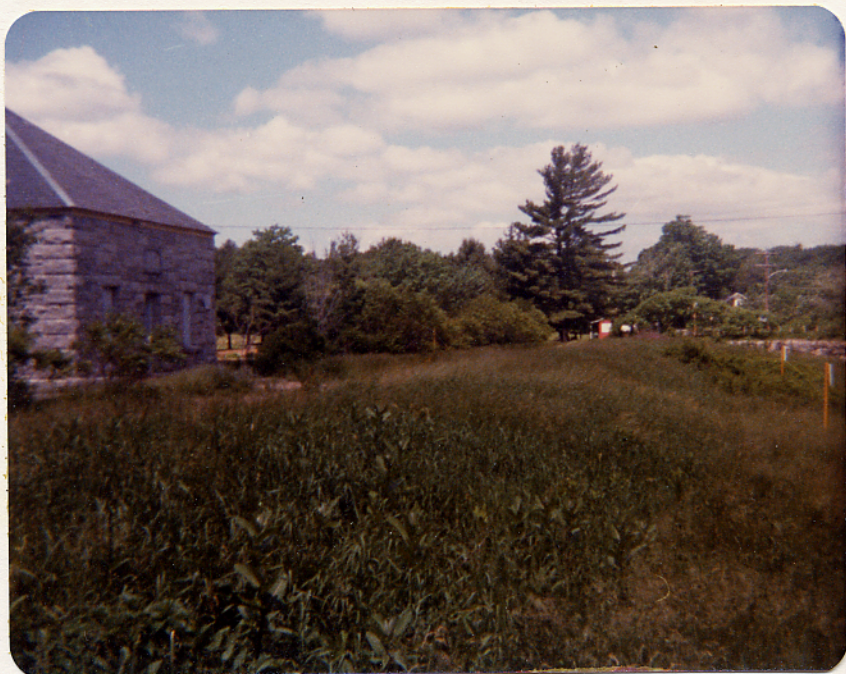
b. Dam. The almost 80-year old Wyman Pond Dam appears to be in good condition. No significant vertical or horizontal misalignments were observed, nor were wet spots on the downstream surface. The dam is generally covered by low vegetation.

Downstream Bank of Dam

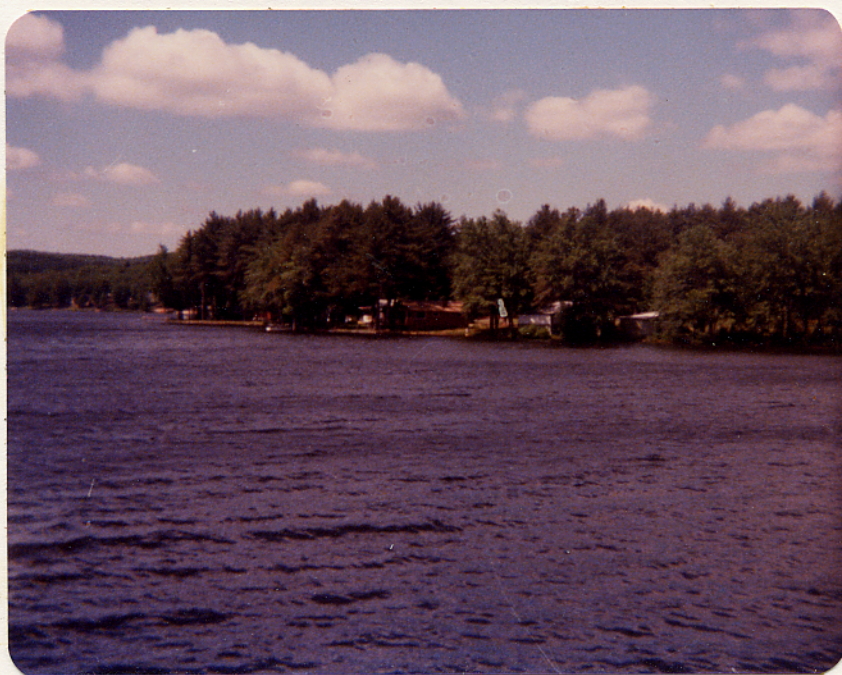
Upstream View of Reservoir

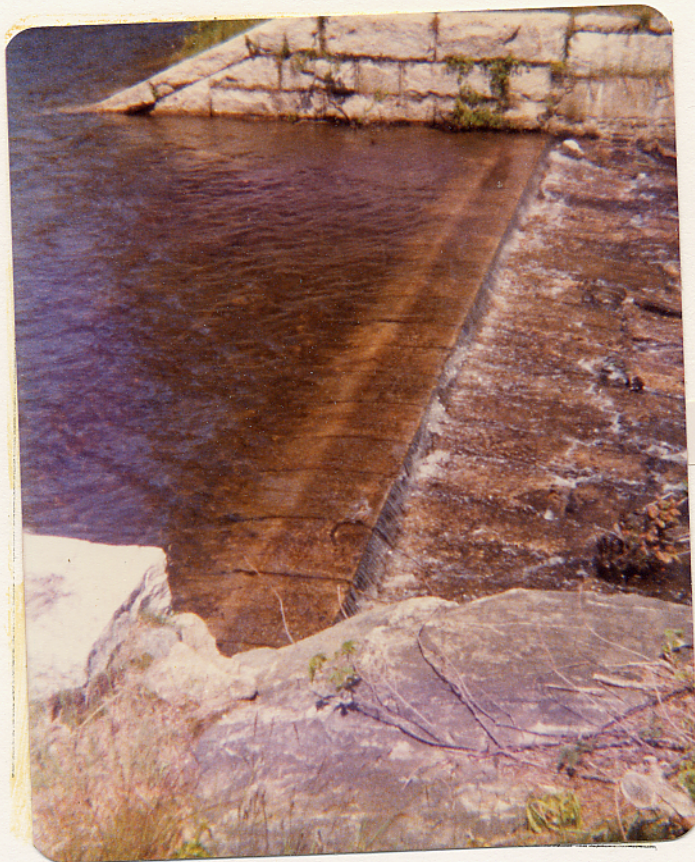
3

c. Appurtenant Structures. The granite block spillway structure and its extension leading to the culvert under the highway is in fair condition structurally, although there is growth in some joints and in the channel. The locked granite block gatehouse structure appeared to be well maintained.

View of Spillway from Top of Dam

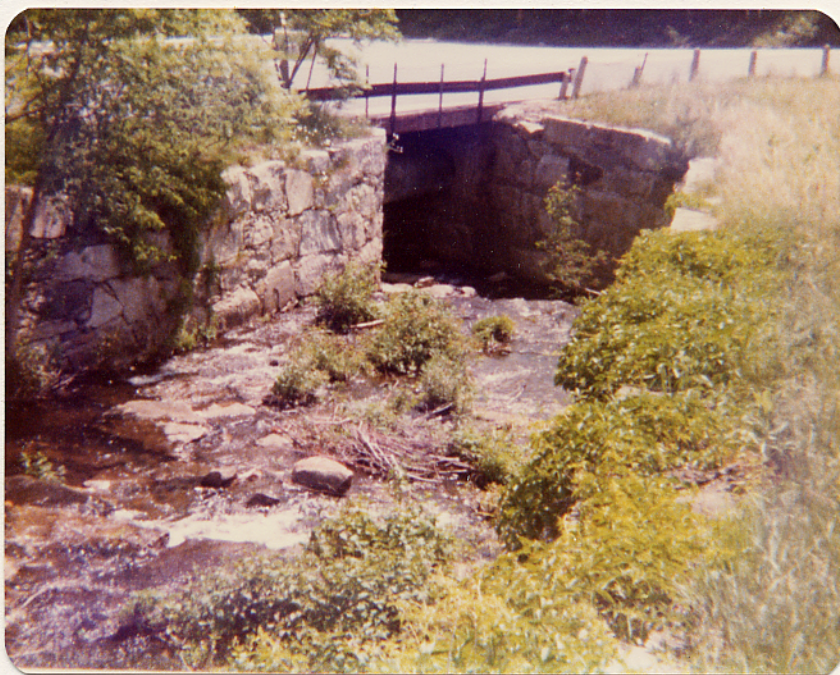
4

c. Visual Observations. There is a highway intersection just downstream of the dam. The culvert under the highway cannot, obviously, pass high flows. The channel contains considerable growth and debris which would affect small flows.

Downstream View of Spillway Channel
